REPAIR AND PREVENTATIVE MAINTENANCE
OF THE
SENECA NIAGARA PARKING GARAGE
NIAGARA FALLS, NEW YORK
MAY 20, 2022

REPAIR AND PREVENTATIVE MAINTENANCE
OF THE
SENECA NIAGARA PARKING GARAGE
NIAGARA FALLS, NEW YORK

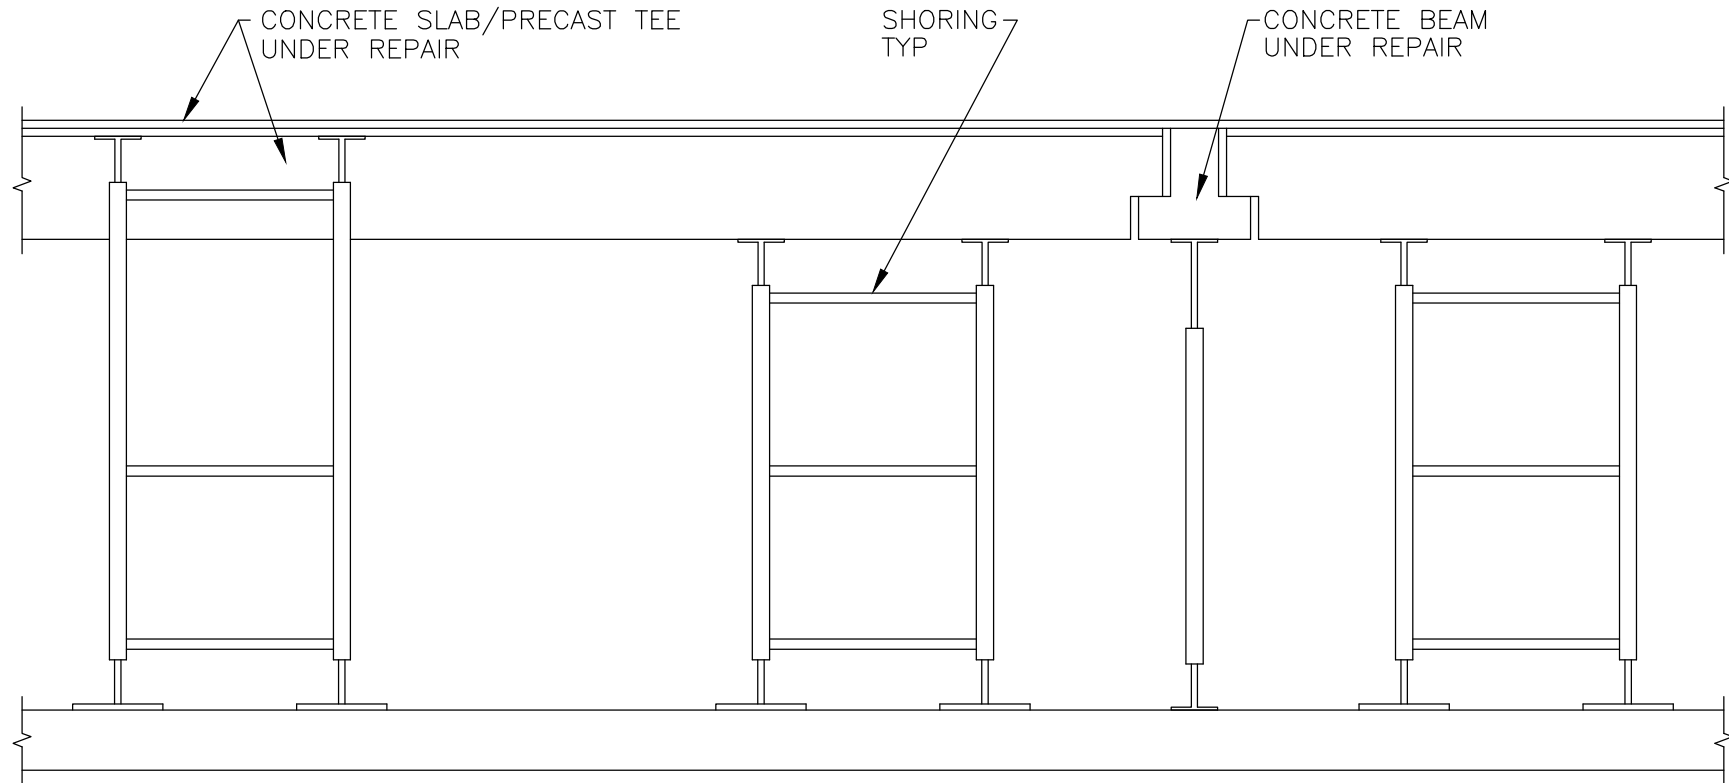
3 SHORING DETAILS/REQUIREMENTS FOR SLAB REPAIRS

NOTE: THIS SKETCH IS FOR DEMONSTRATIVE PURPOSES, AND DOES NOT IMPLY ANY SHORING CONCEPTS, DESIGNS, OR TECHNIQUES TO THE CONTRACTOR, SHORING DESIGNER, OR ERECTOR.

1. THE CONTRACTOR SHALL PROVIDE ALL SHORING, BRACING, AND SHEETING REQUIRED FOR SAFETY AND PROPER EXECUTION OF THE WORK. THE CONTRACTOR WILL BE RESPONSIBLE ALL OF THE SHORING DESIGN, INSTALLATION, AND MAINTENANCE FOR THE IMPLEMENTATION OF THE REPAIRS.

2. THE CONTRACTOR SHALL HAVE FULL RESPONSIBILITY FOR THE ERECTION AND MAINTENANCE OF THE SHORING SYSTEM DURING THE REPAIR WORK. ON A DAILY BASIS, THE SHORING SYSTEM SHALL BE CHECKED TO ENSURE TIGHTNESS TO THE SOFFIT AT ALL LOCATIONS.

9. THE SHORING SYSTEM SHALL BE DESIGNED SO THAT THE CONCRETE MEMBERS UNDER REPAIR AND ADJACENT TO MEMBERS UNDER REPAIR DO NOT EXPERIENCE ANY DEFLECTION DURING THE CONSTRUCTION PHASE WHEN FULL/PARTIAL DEPTH CONCRETE IS REMOVED ALONG WITH REINFORCING BARS.
10. THE CONTRACTOR SHALL BE RESPONSIBLE FOR ALL WALL/COLUMN SHORING DESIGN, INSTALLATION, AND MAINTENANCE AT WALL/COLUMN REPAIRS AND LOCATIONS WHERE LATERAL SUPPORT IS PARTIALLY/FULLY REMOVED FROM THE EXISTING WALLS/COLUMNS DUE TO FLOOR SLAB AND BEAM REPAIRS.

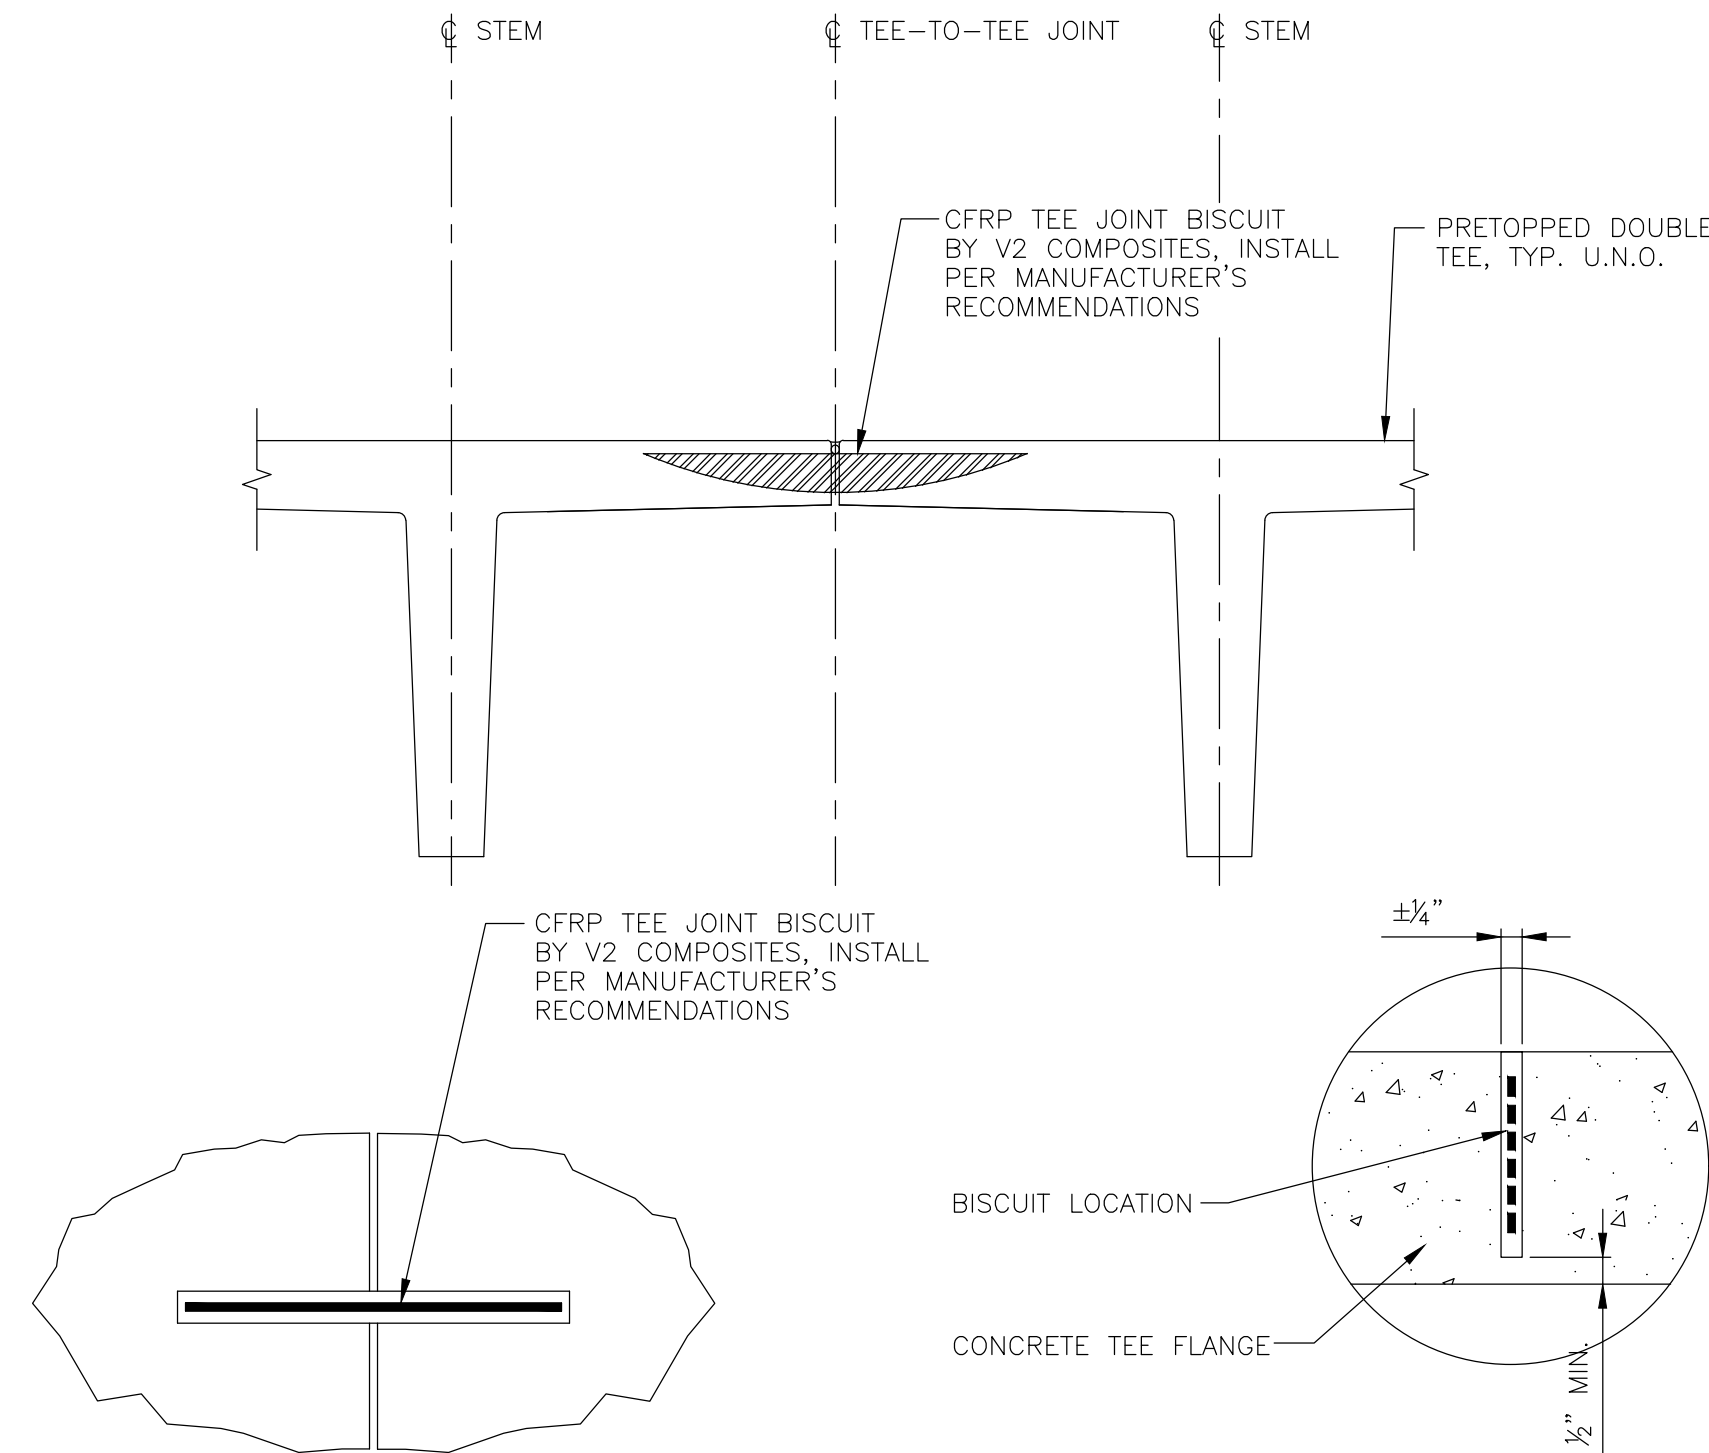
6 TEE-TO-TEE CONNECTION REPAIR DETAIL

TOP VIEW

SECTION VIEW

8. PERFORM TEE-TO-TEE CONNECTION REPAIRS AT LOCATIONS DESIGNATED BY THE ENGINEER ACCORDING TO THE SPECIFICATIONS AND REPAIR DETAIL SHEETS.
9. INSTALL STRIPING IN PARKING AREAS, DIRECTIONAL MARKINGS IN TRAFFIC AREAS, AND SAFETY MARKINGS AT ALL CURBS, ISLANDS, STAIRS, ETC. AFFECTED BY CONSTRUCTION ACTIVITIES ACCORDING TO THE SPECIFICATIONS.

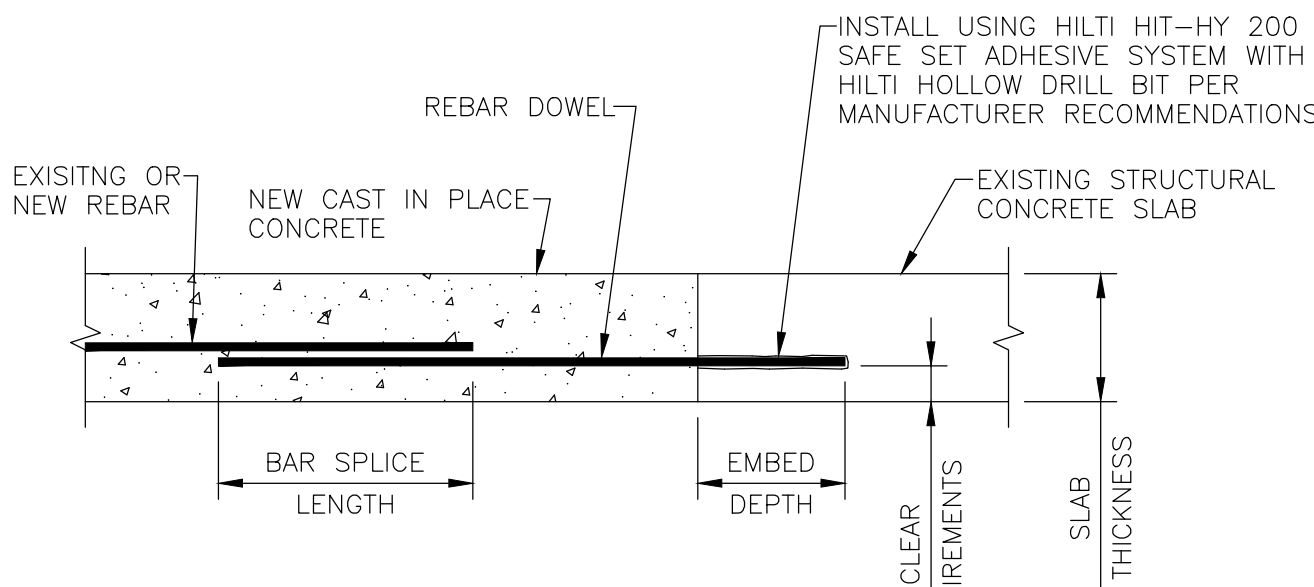
4 DOWEL DETAIL

1. FOR DOWEL DEVELOPMENT AND BAR SPLICE LENGTHS, SEE GENERAL NOTES, DWG S0.01
2. FOR EMBEDMENT DEPTH, CONTACT MANUFACTURER

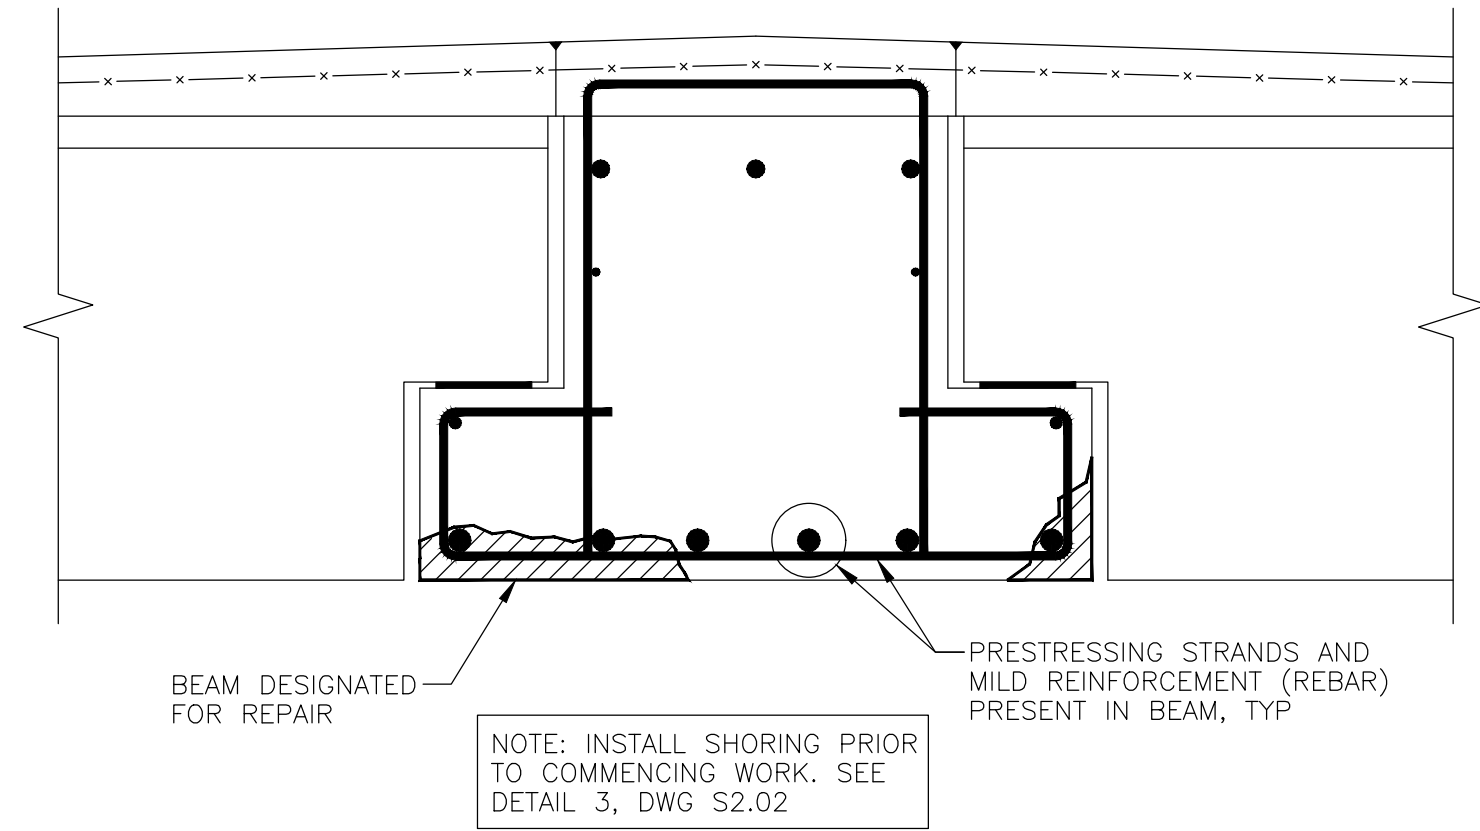
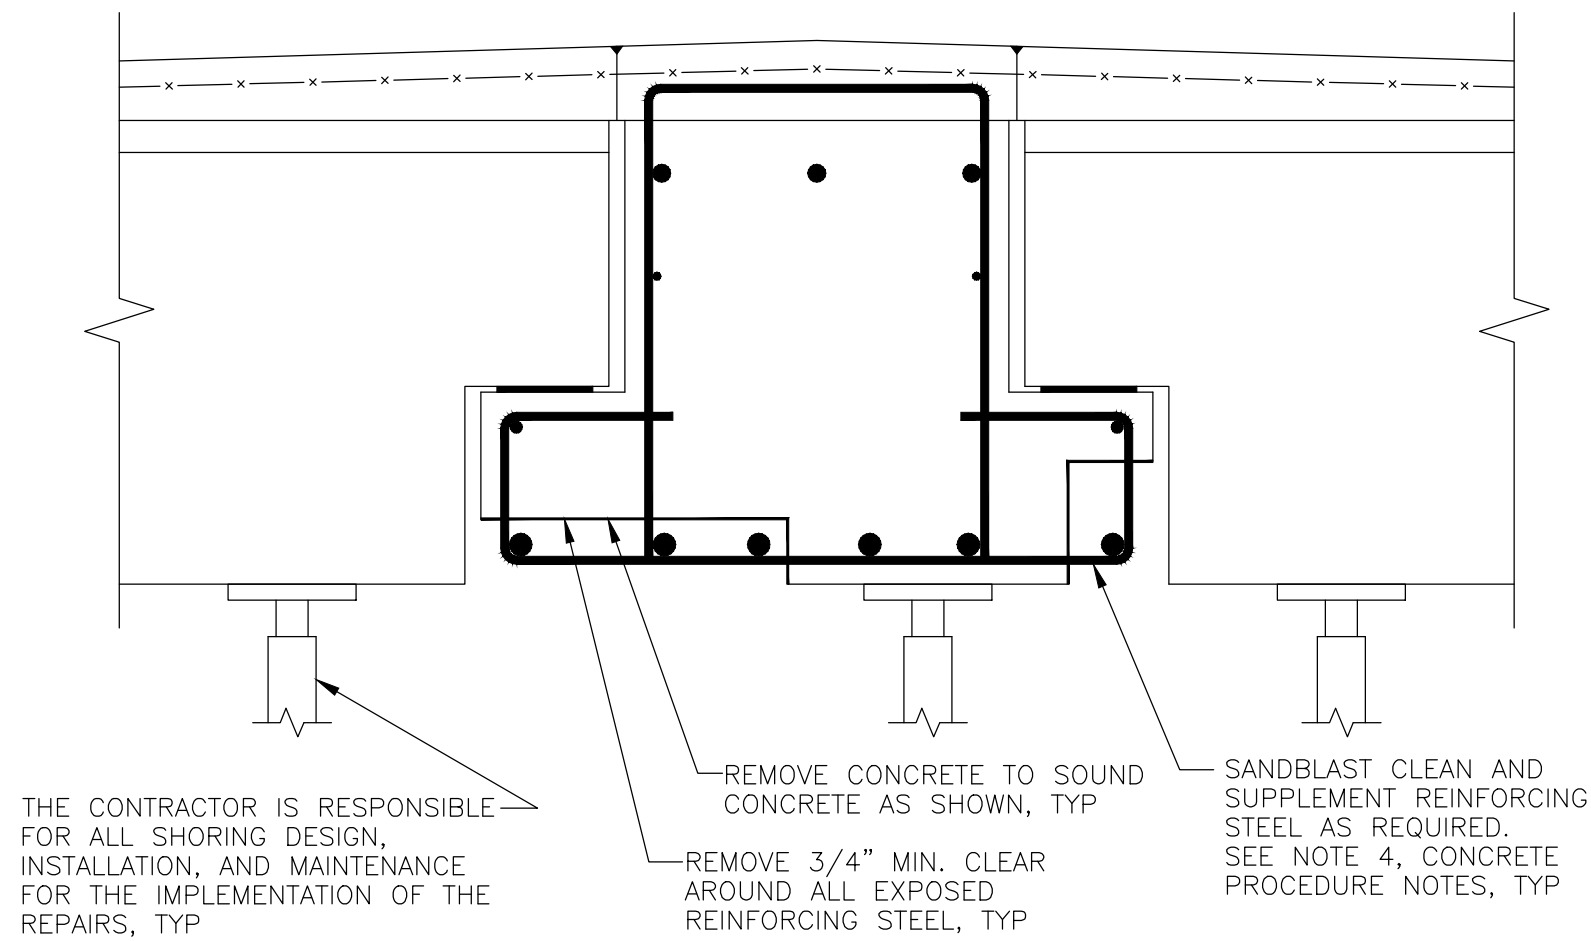
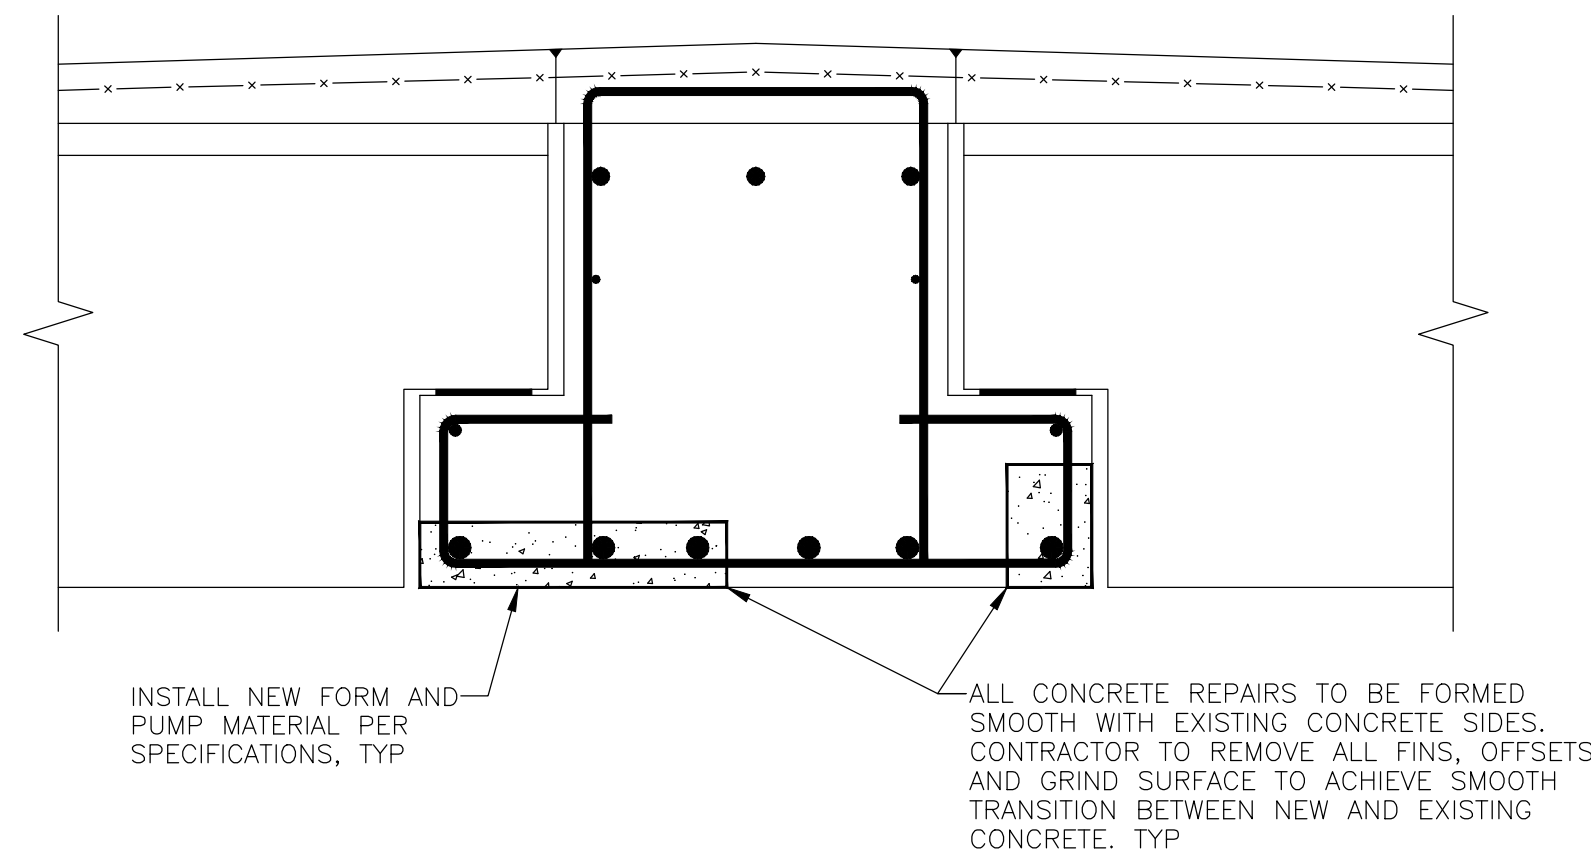
7 PARTIAL DEPTH BEAM REPAIR DETAIL

EXISTING CONDITION

CONCRETE REMOVAL

REPAIRED CONDITION

BEAM REPAIR (#) - DENOTES PARTIAL DEPTH BEAM REPAIR
(AREA IN S.F.), SEE DETAIL 7, DRAWING S2.02

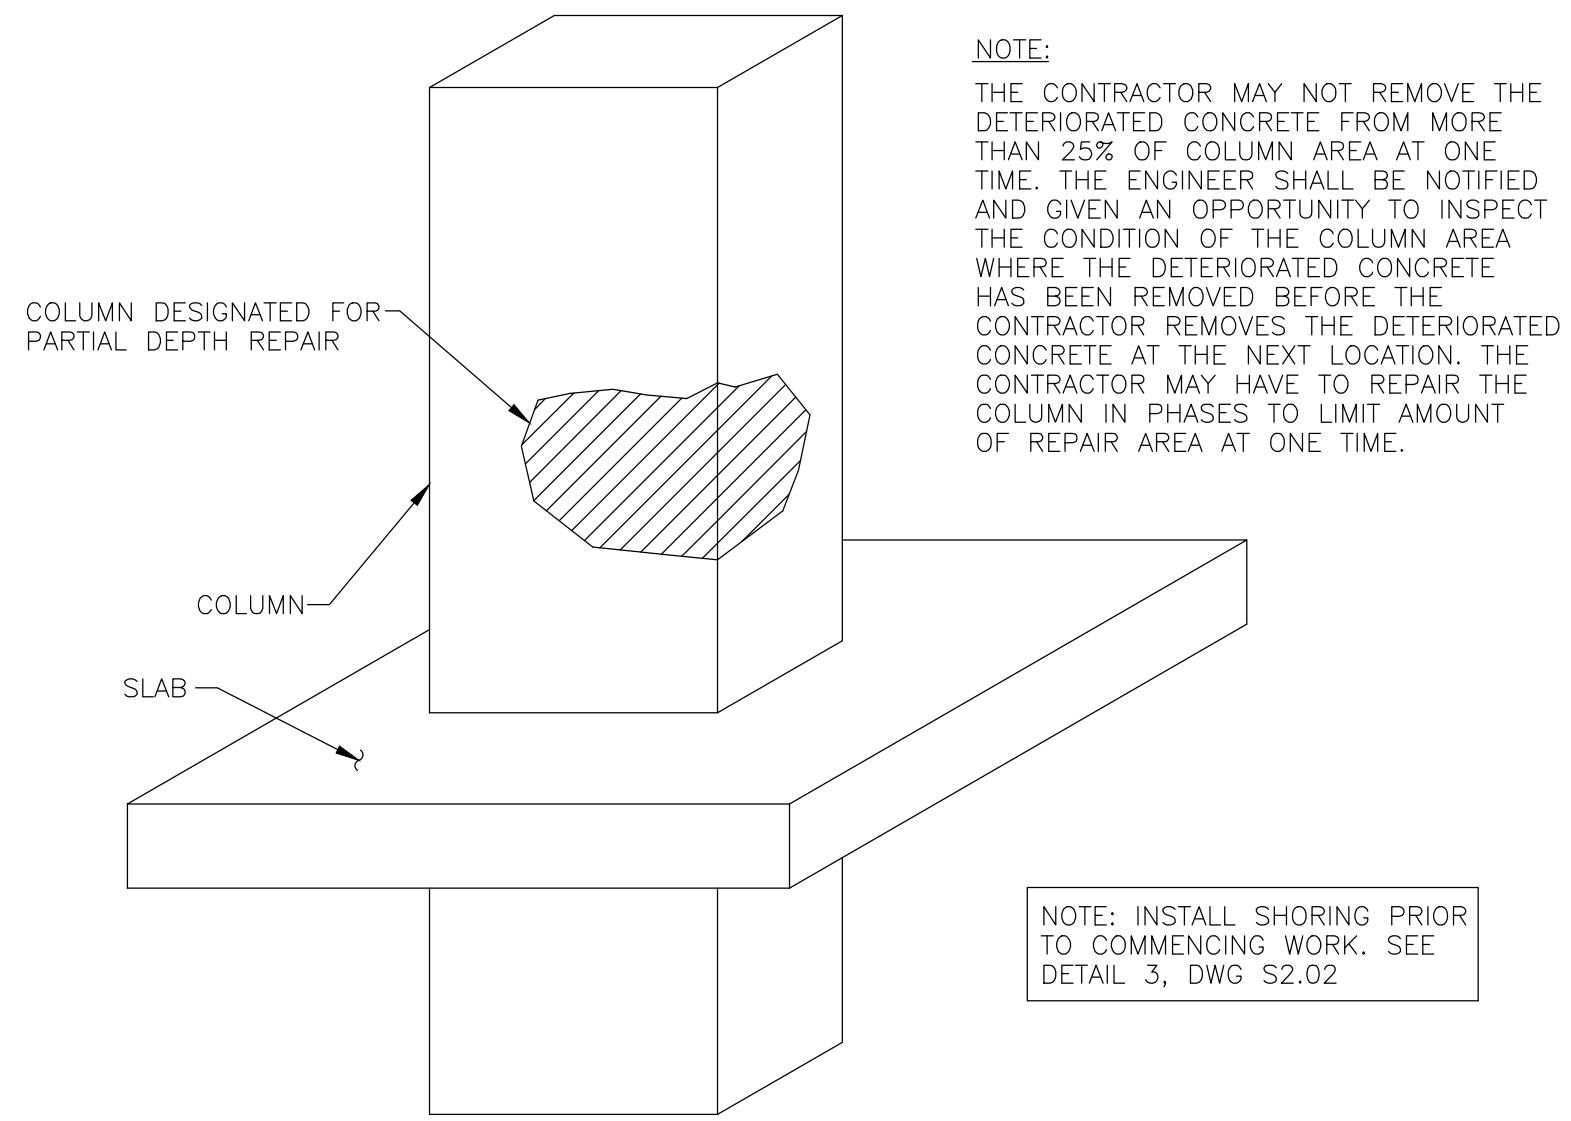
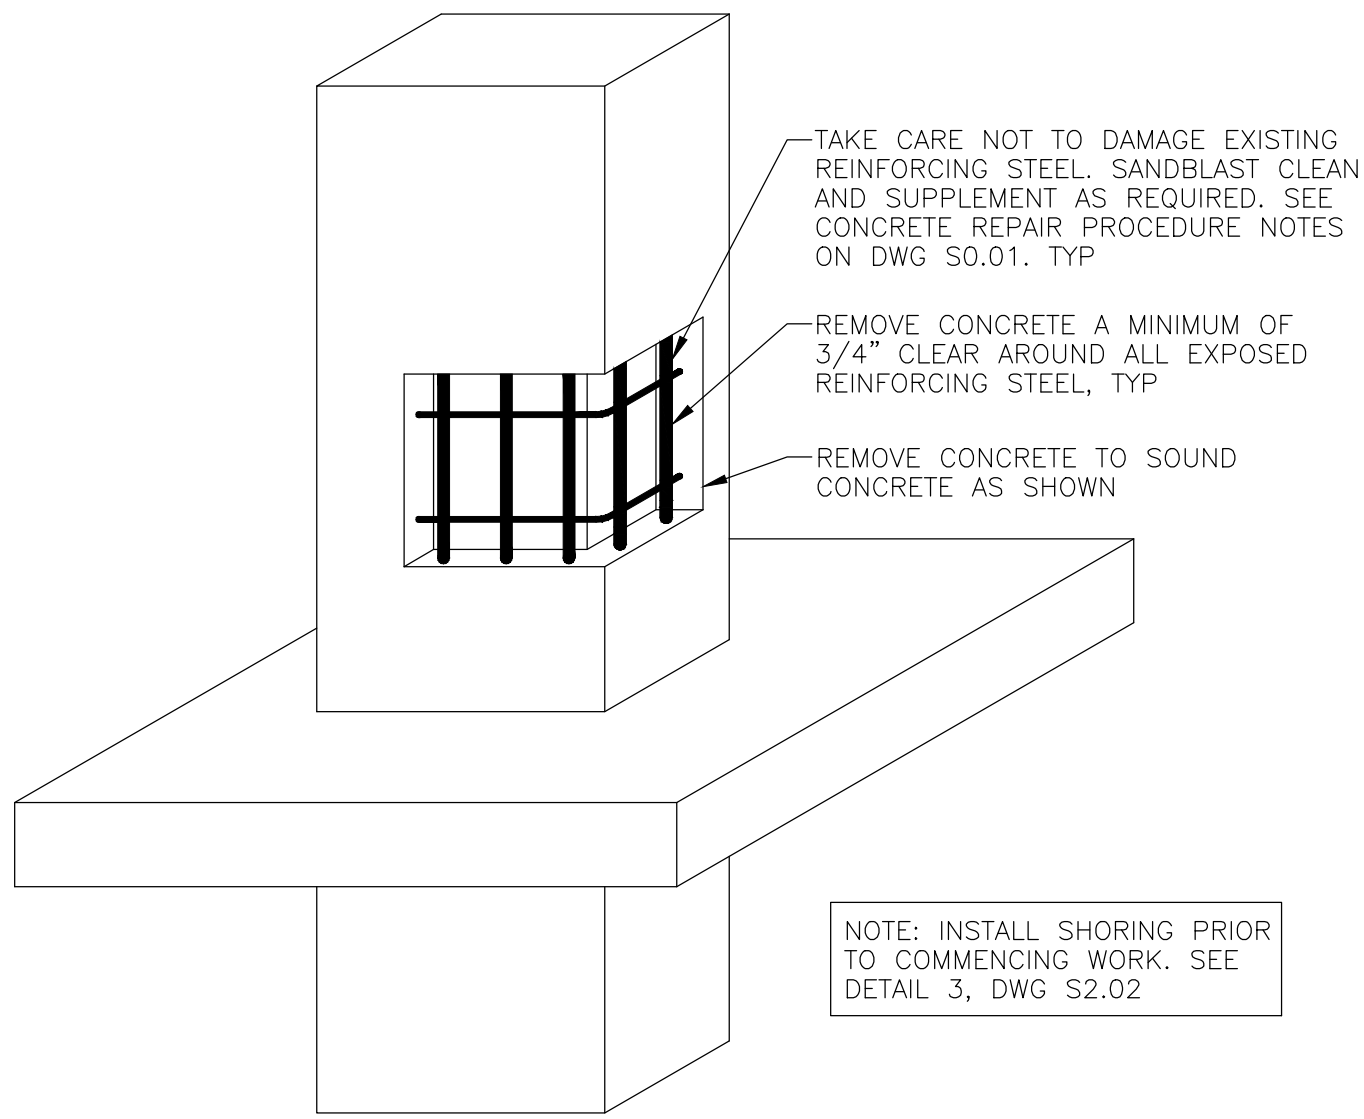
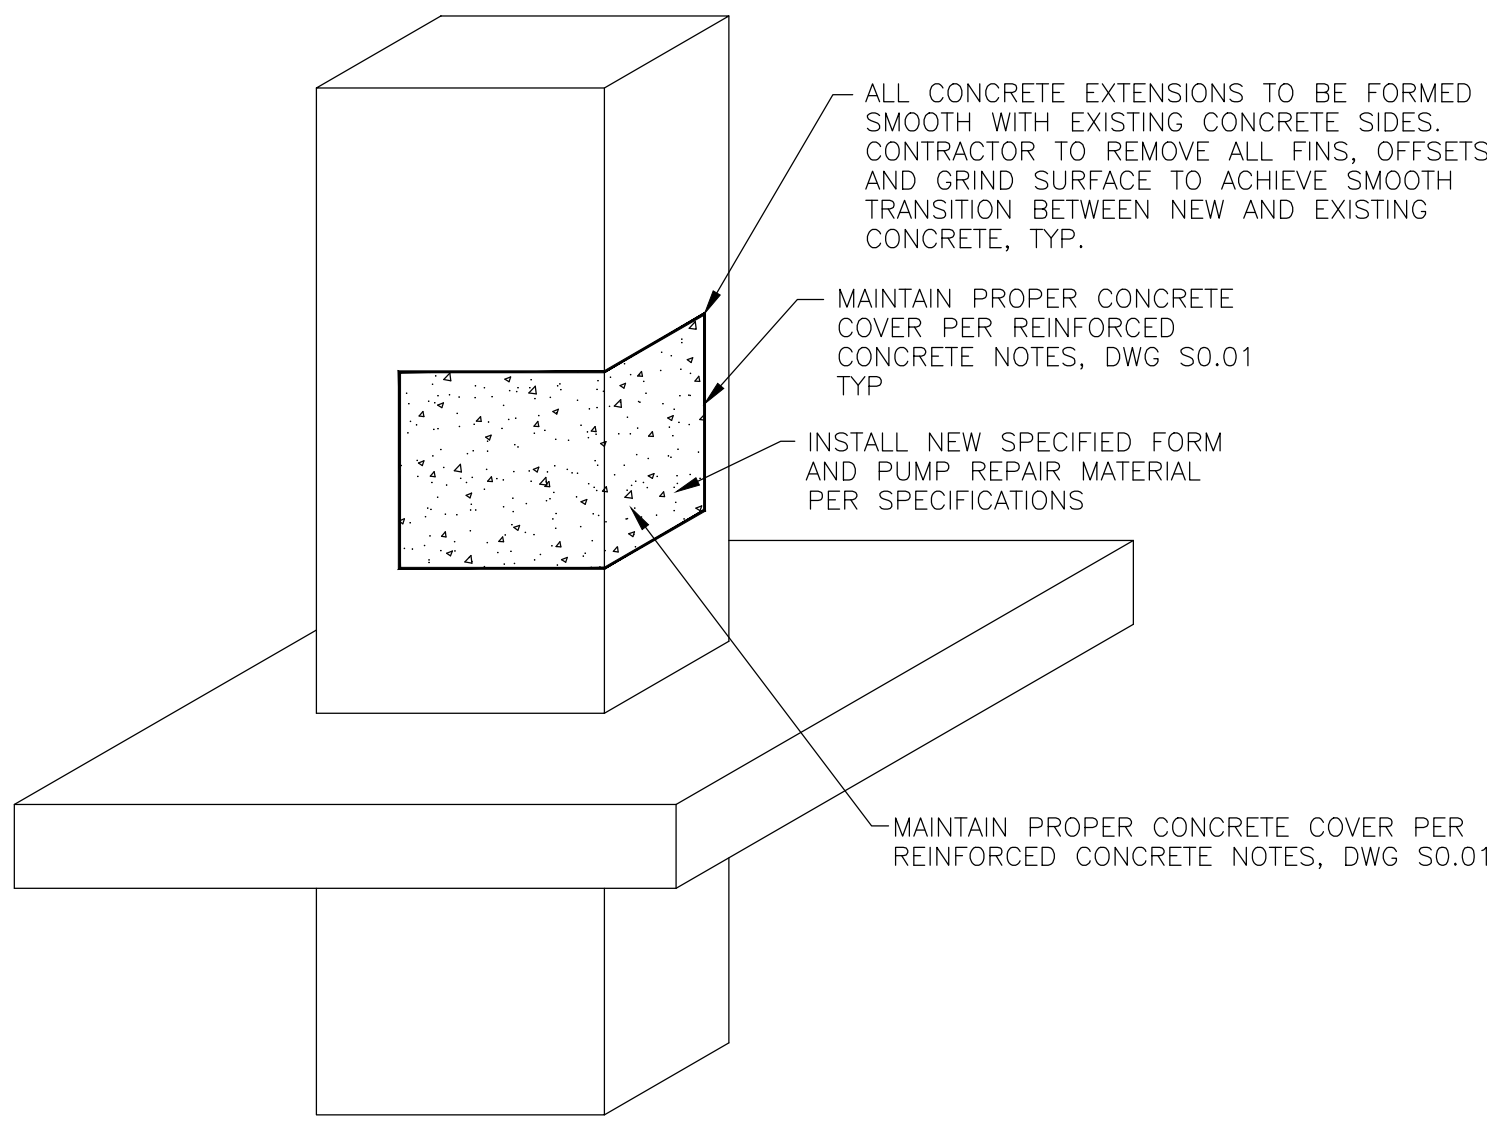
EXISTING CONDITION

CONCRETE REMOVAL

REPAIRED CONDITION

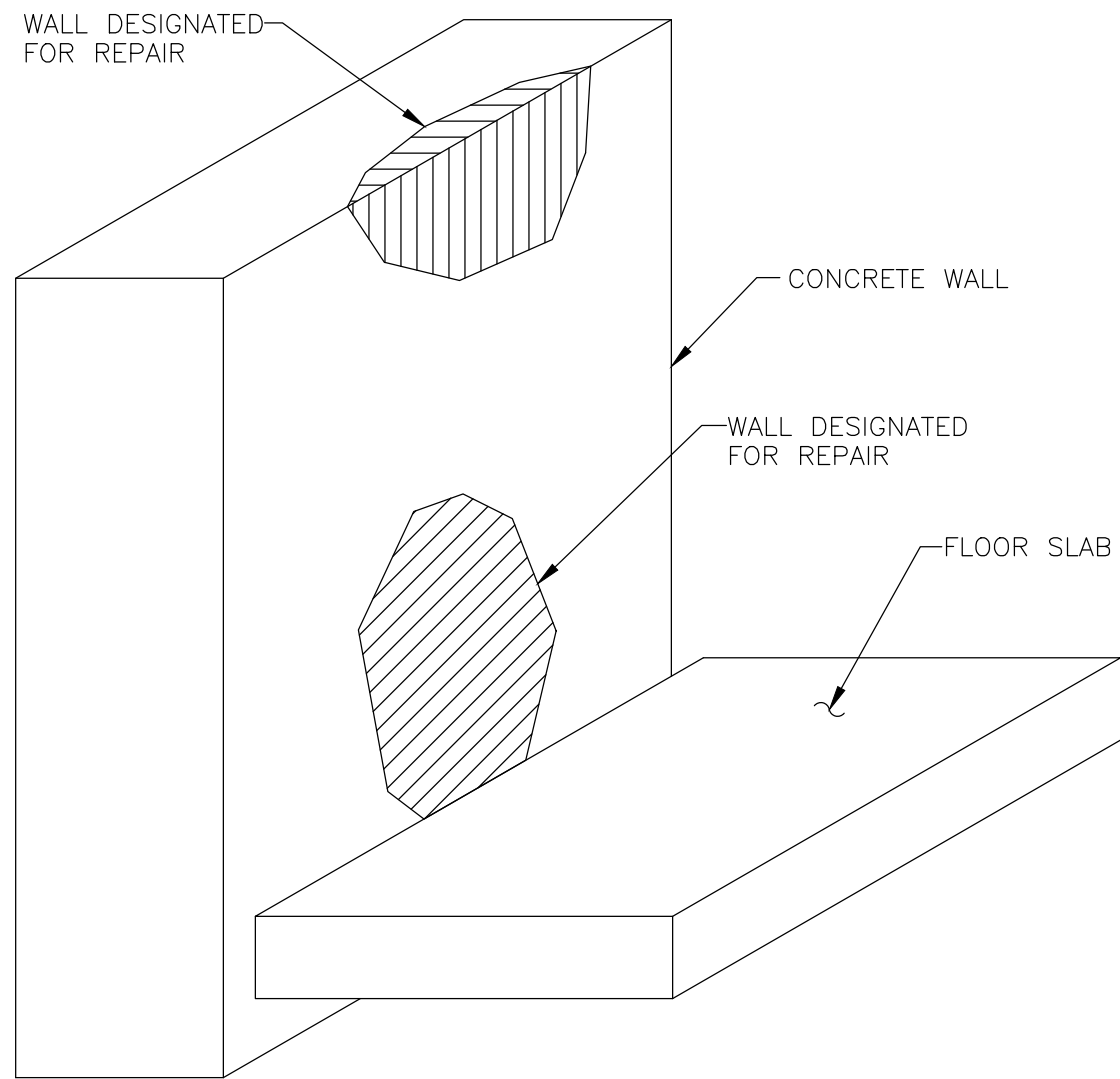
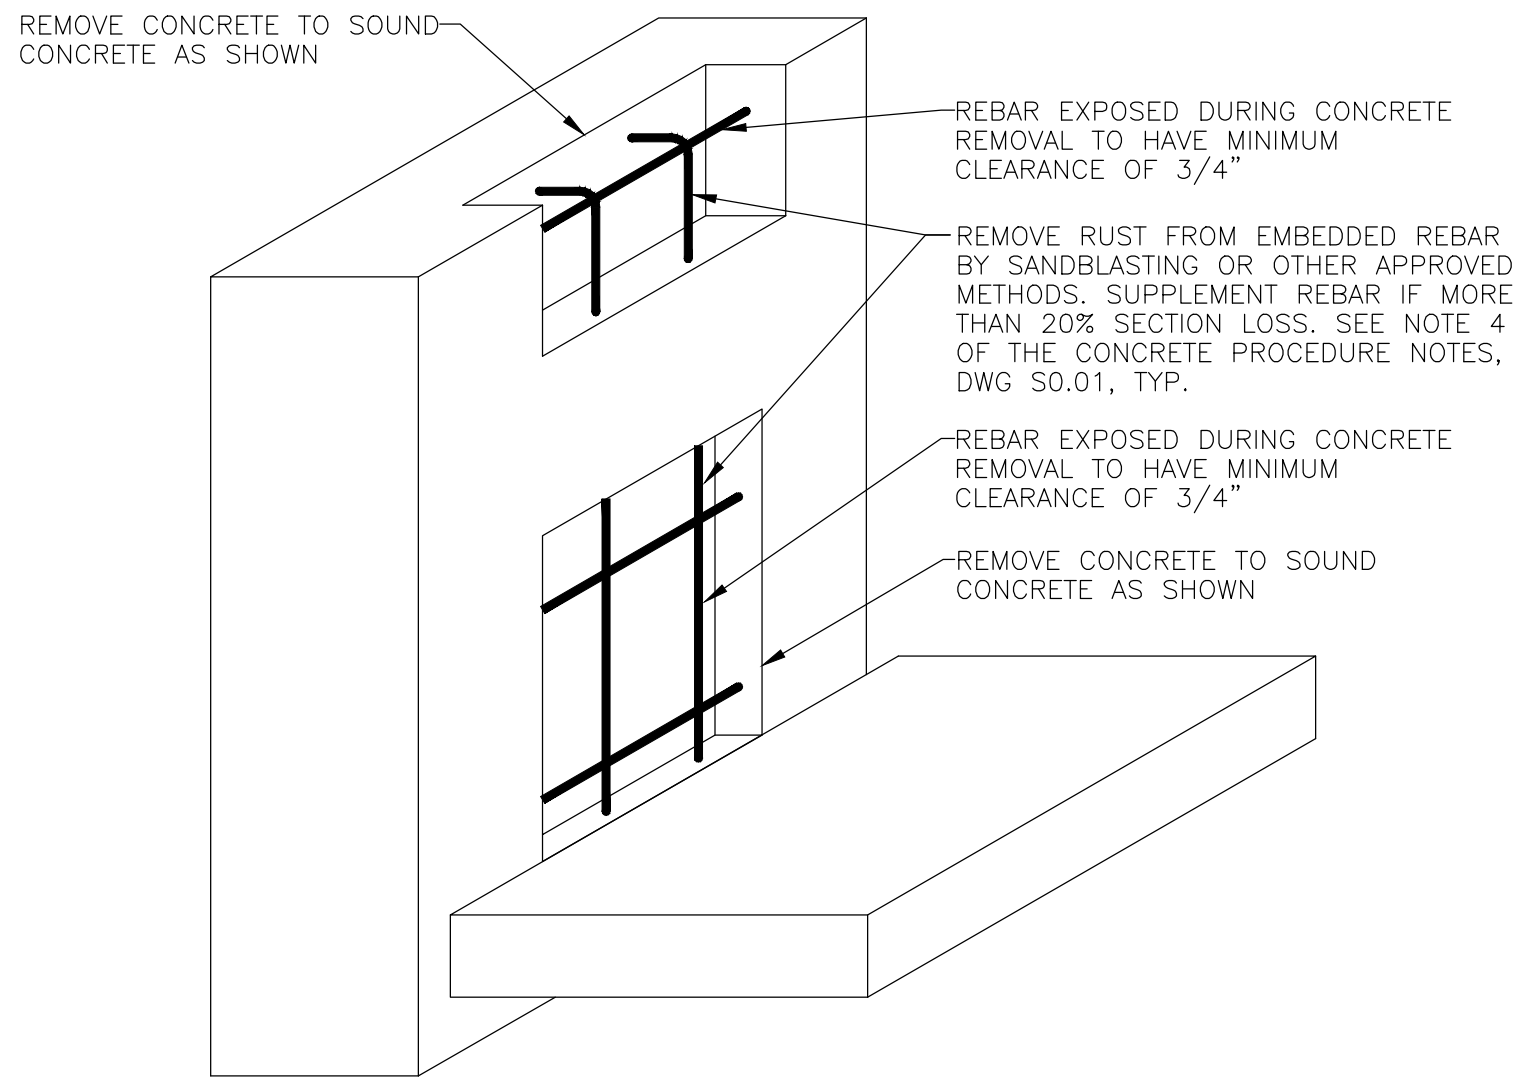
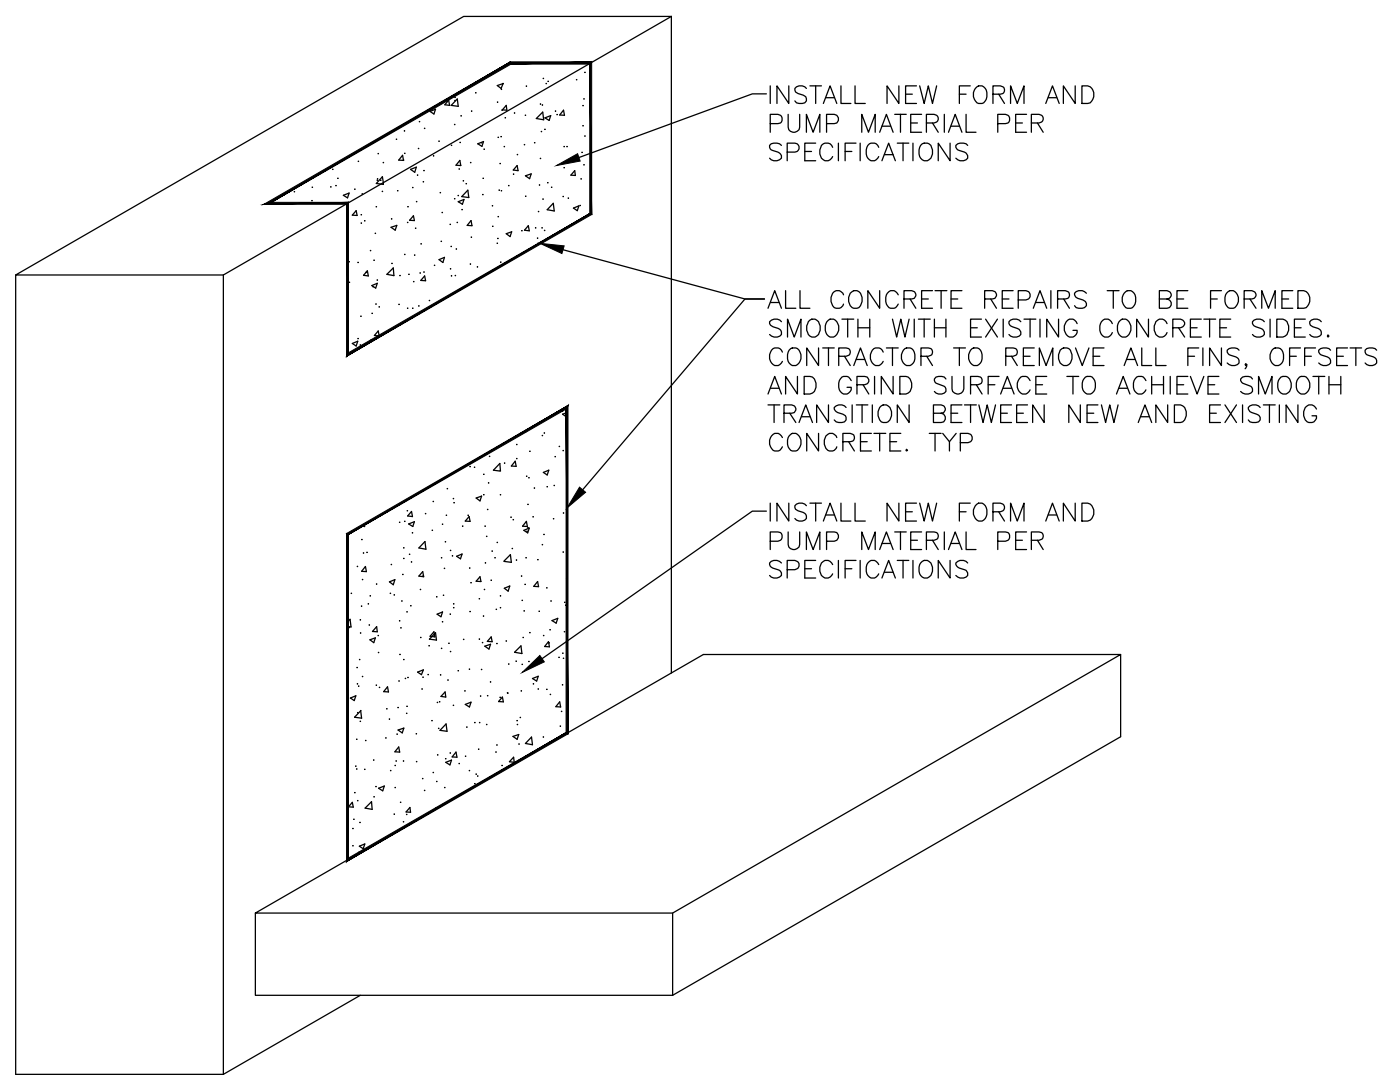
EXISTING CONDITION

CONCRETE REMOVAL

REPAIRED CONDITION
