REPAIR AND PREVENTATIVE MAINTENANCE
OF THE
SENECA NIAGARA PARKING GARAGE
NIAGARA FALLS, NEW YORK
MAY 20, 2022

REPAIR AND PREVENTATIVE MAINTENANCE
OF THE
SENECA NIAGARA PARKING GARAGE
NIAGARA FALLS, NEW YORK

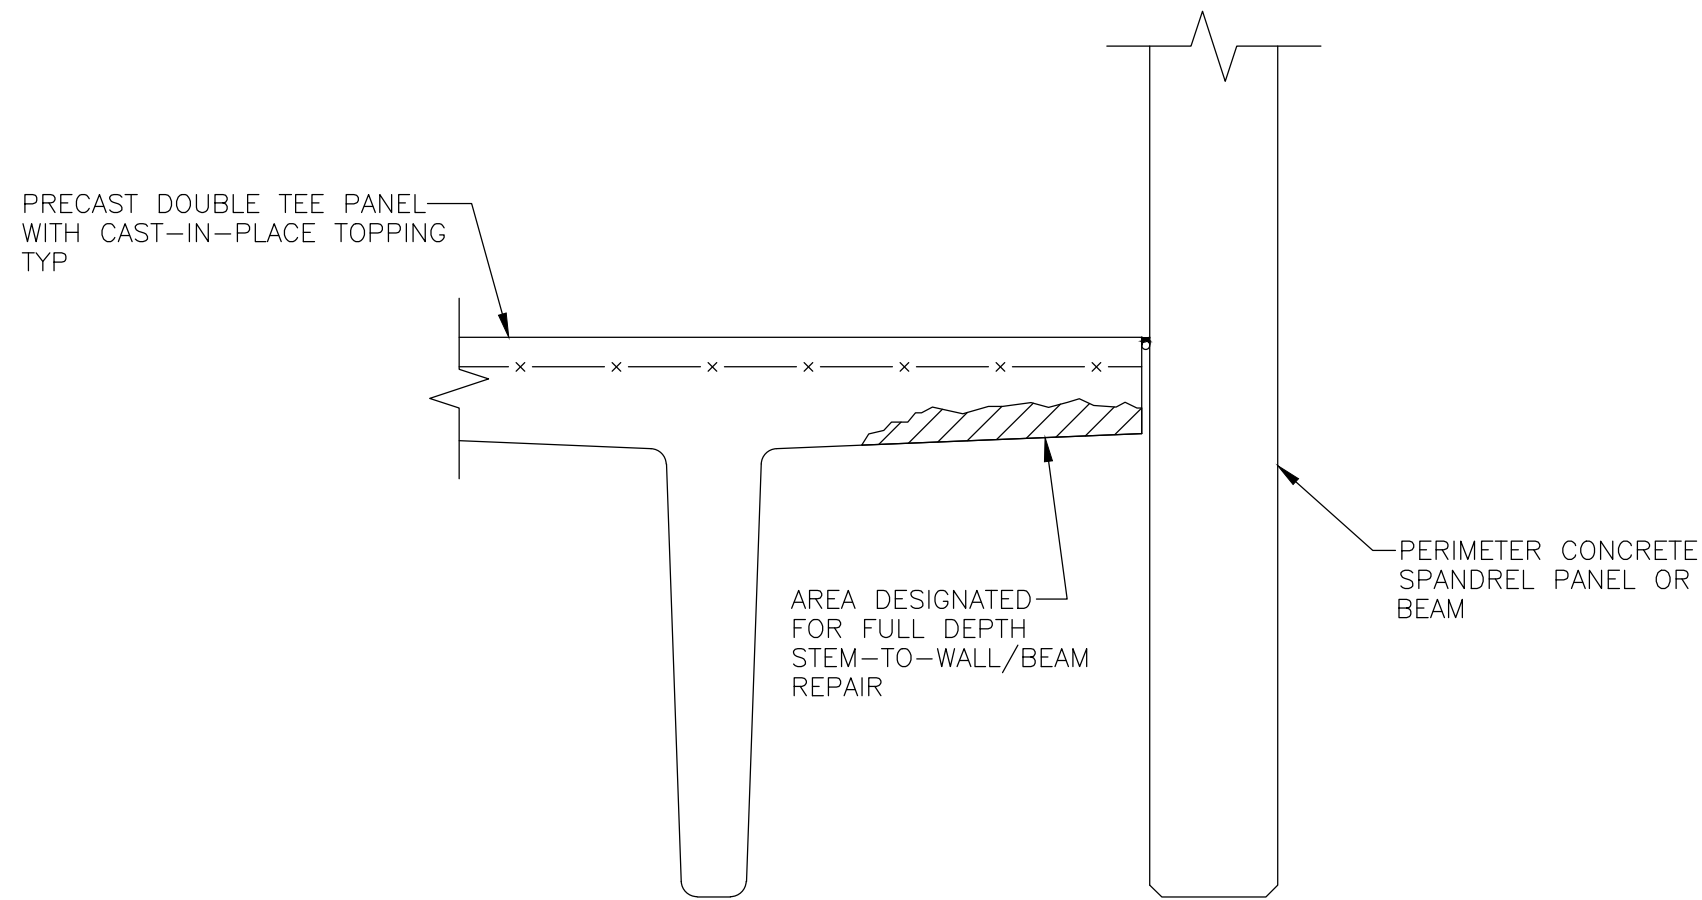
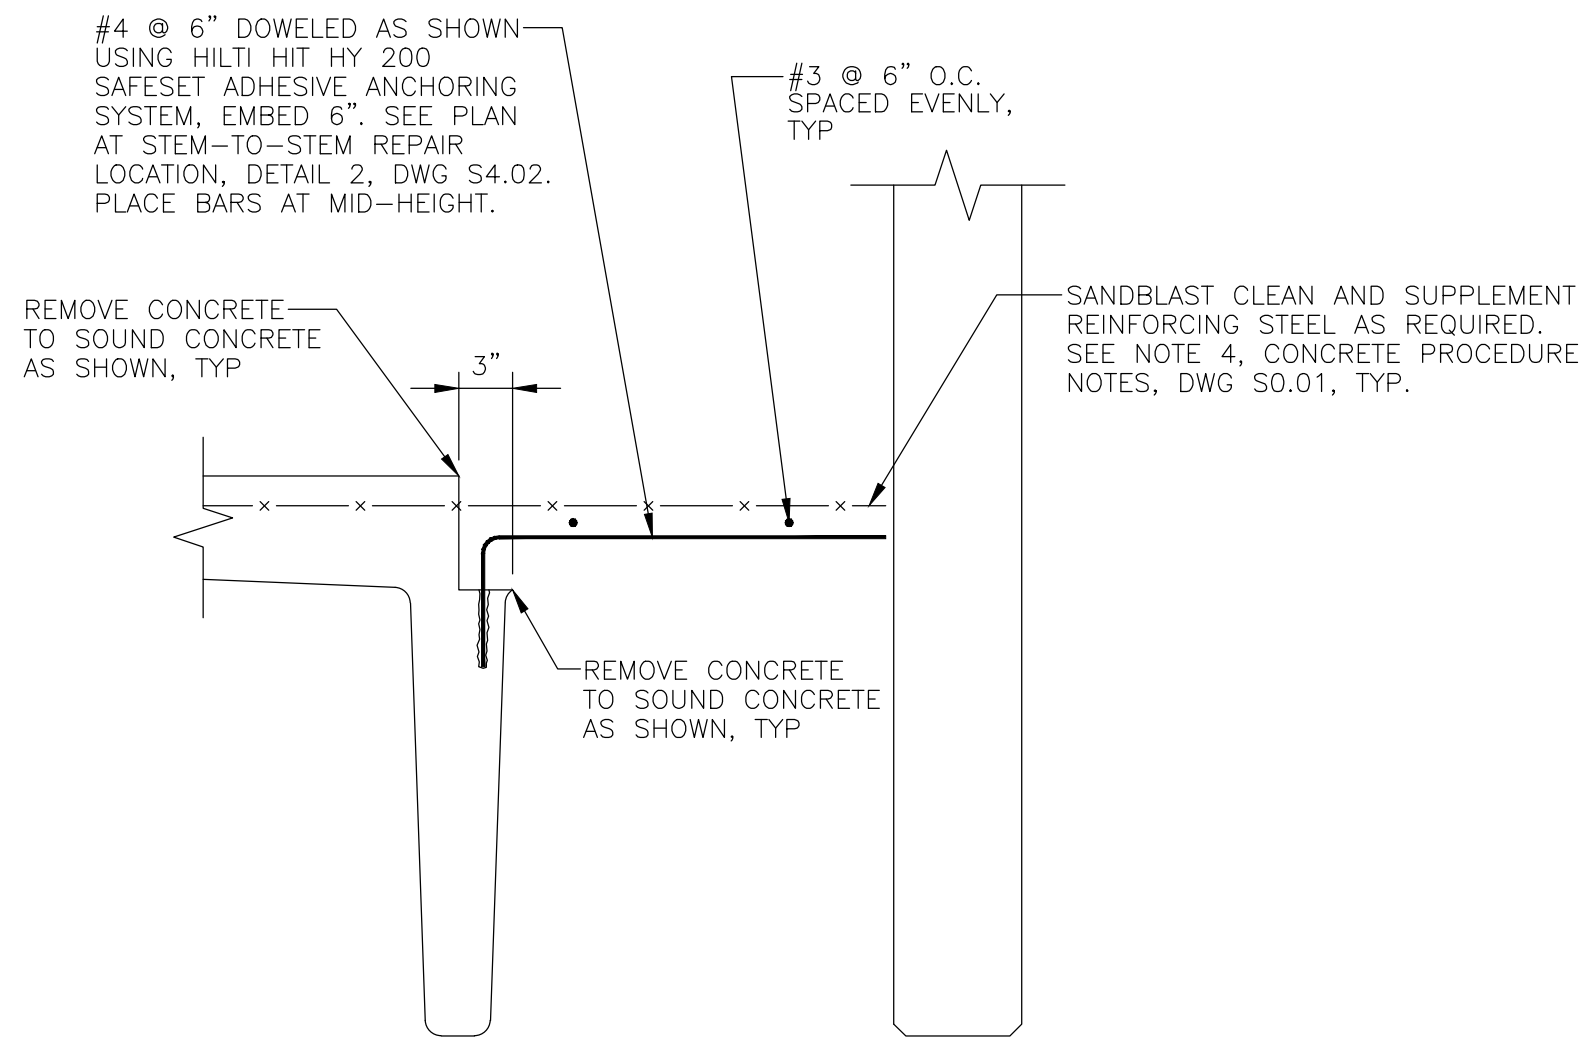
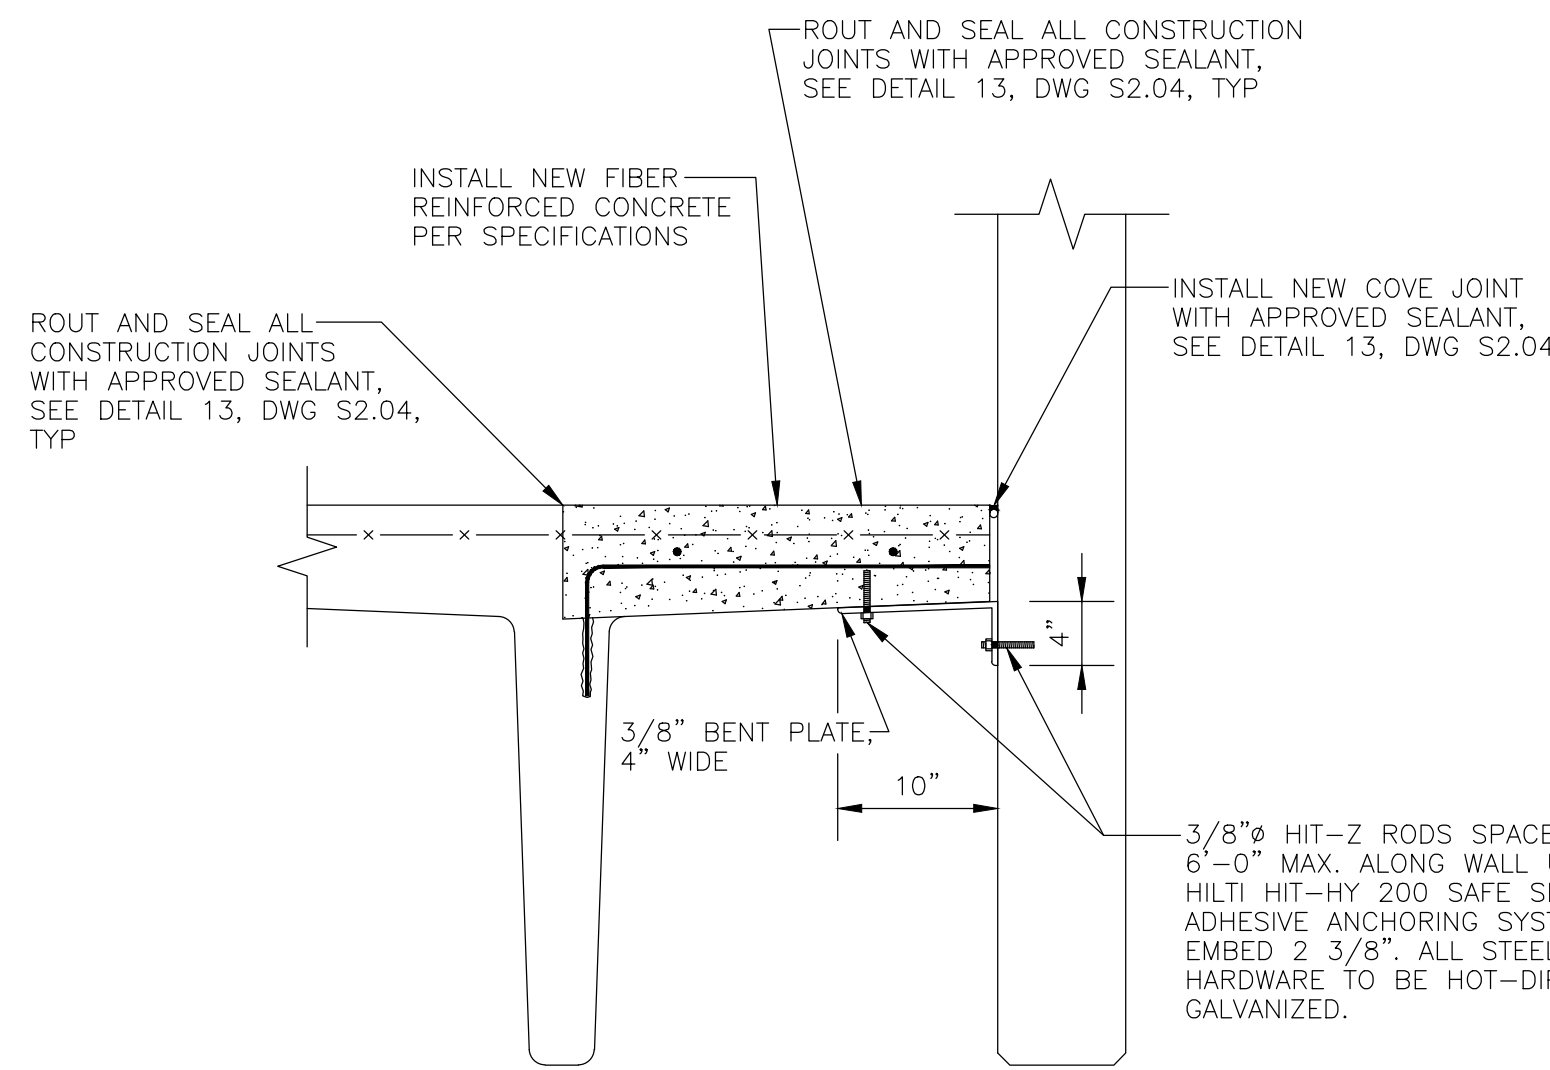
EXISTING CONDITION

CONCRETE REMOVAL

REPAIRED CONDITION

NOTE: MAINTAIN PROPER EDGE DISTANCE PER NOTES ON DRAWING S0.01

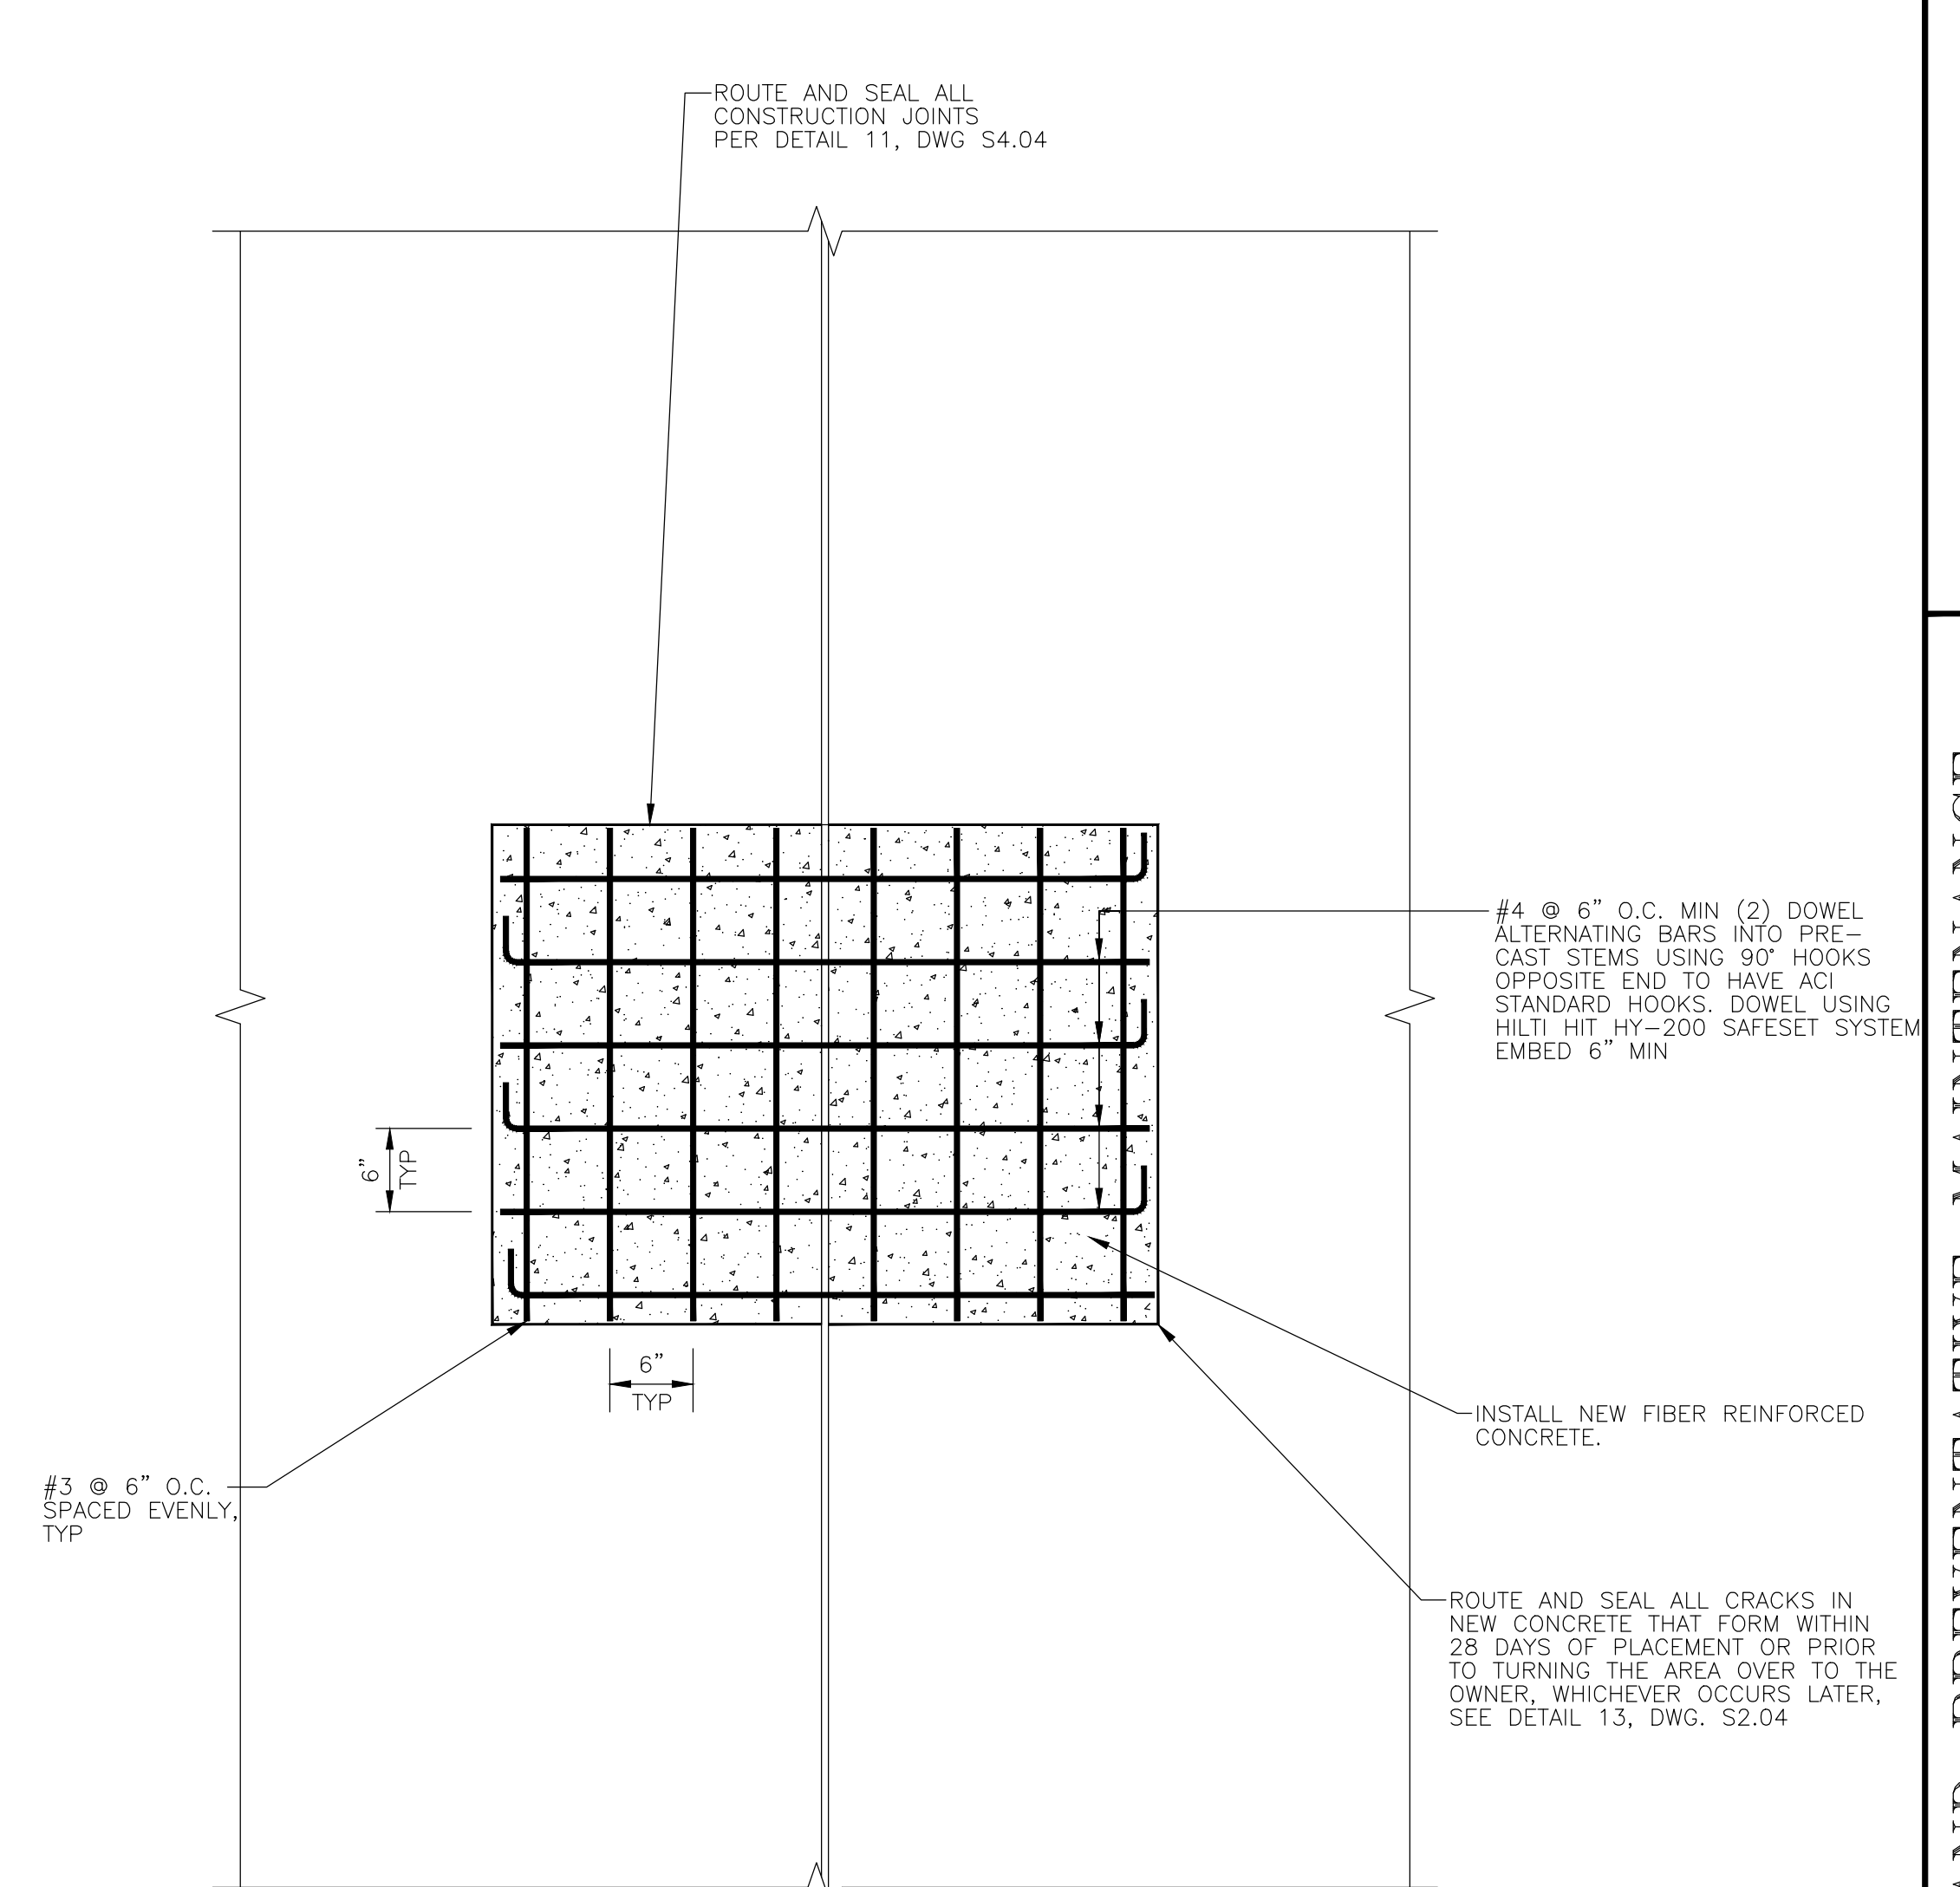
EXISTING CONDITION

CONCRETE REMOVAL

REPAIRED CONDITION

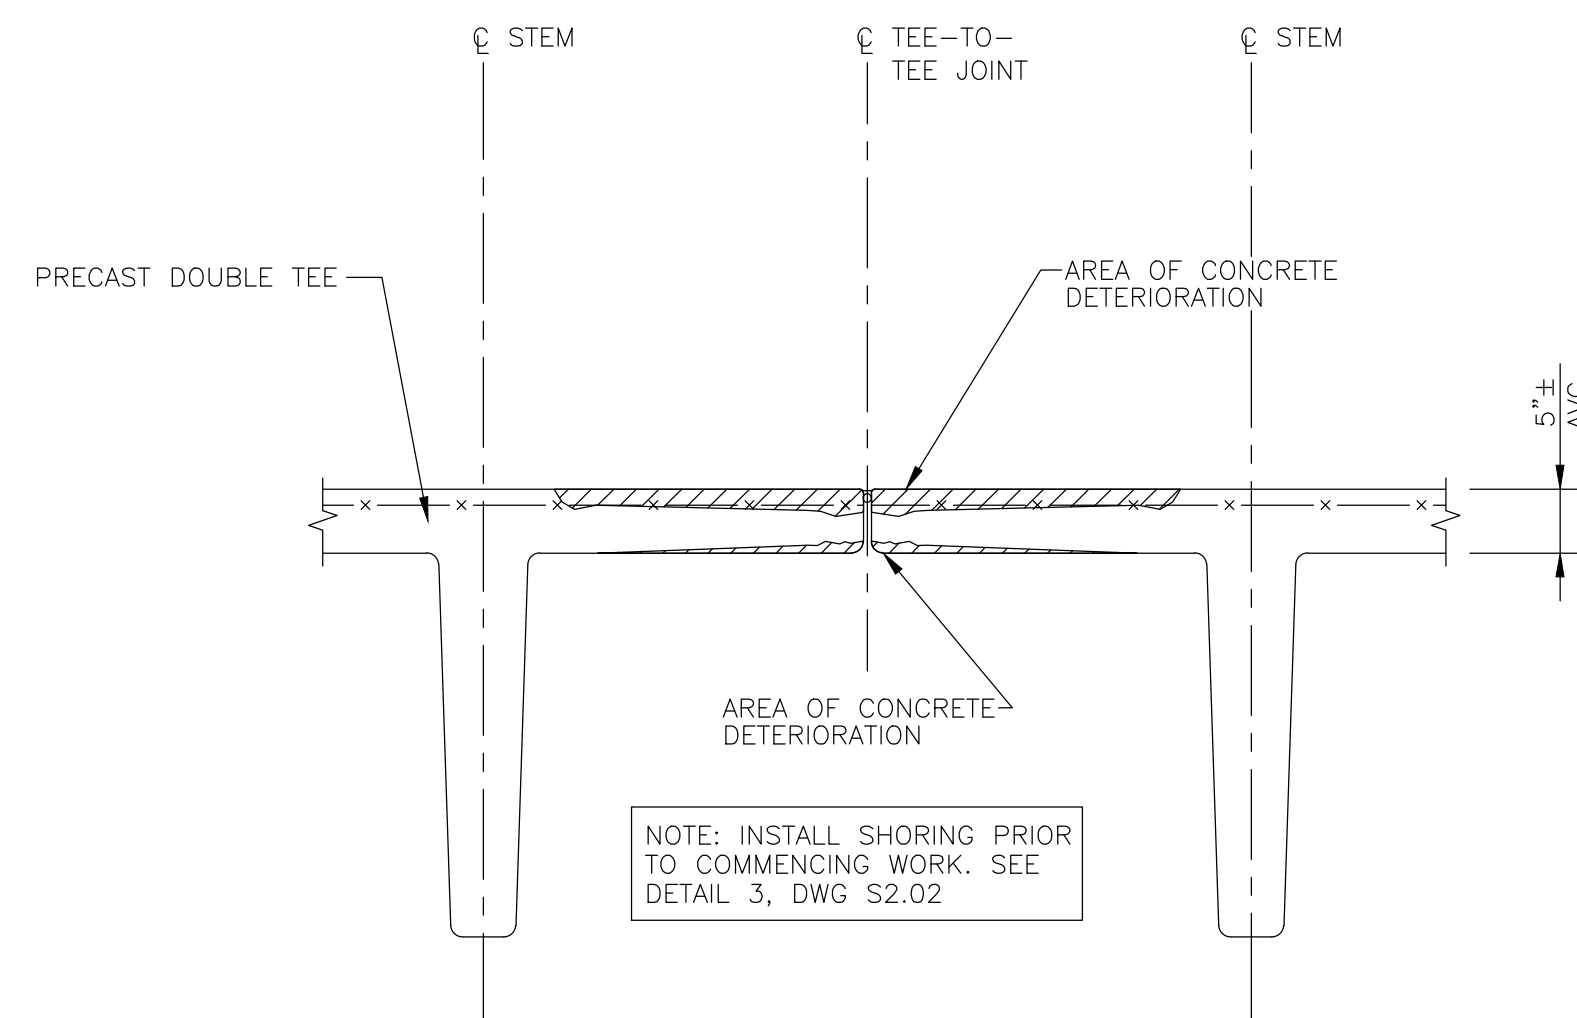
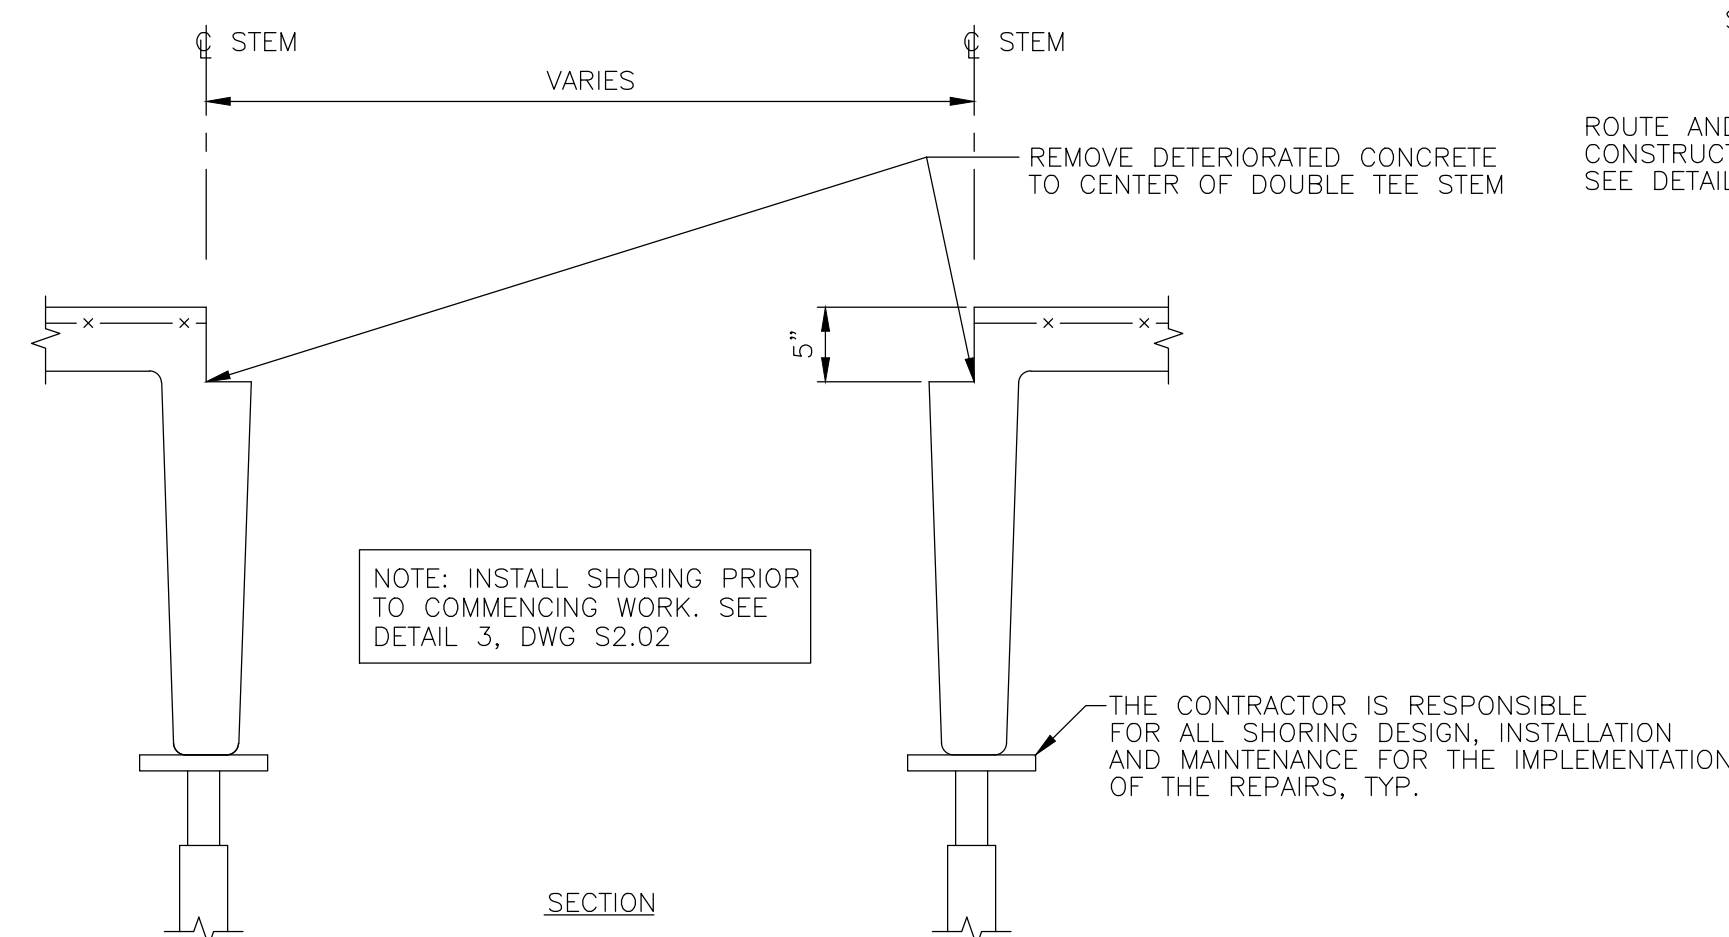
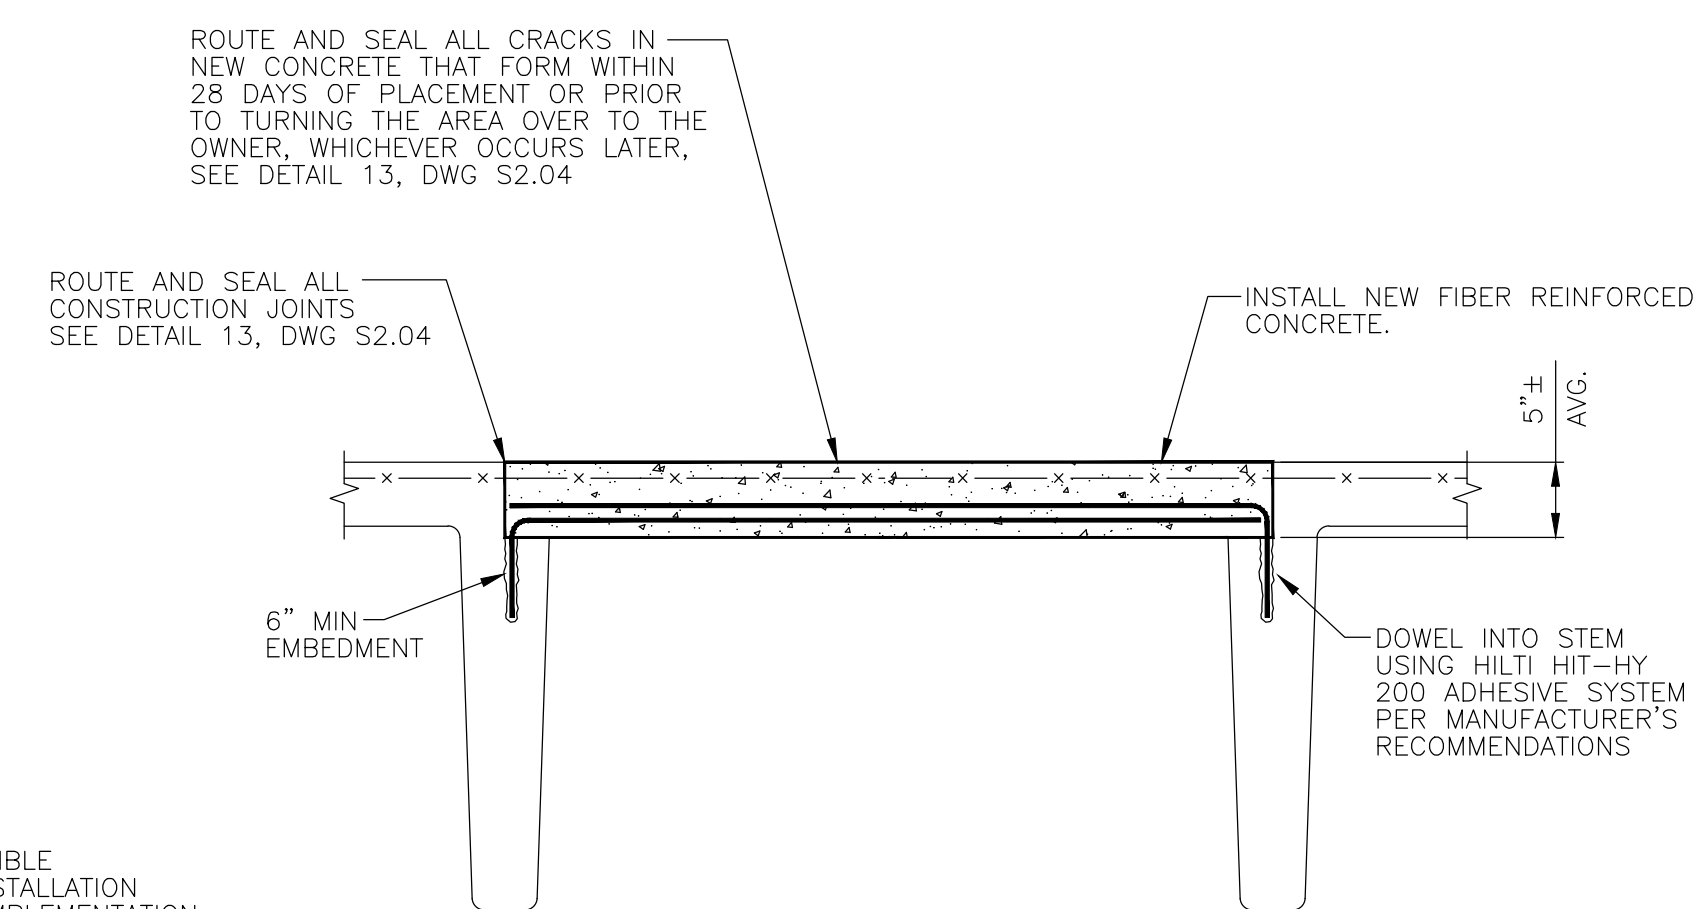
EXISTING CONDITION

CONCRETE REMOVAL

REPAIRED CONDITION
